### Summary of Report: PA-09-188

### Thi Qar Bee Farm

SUBJECT: Report on the Thi Qar Bee Farm, Thi Qar, Iraq (SIGIR Report Number PA-09-188)

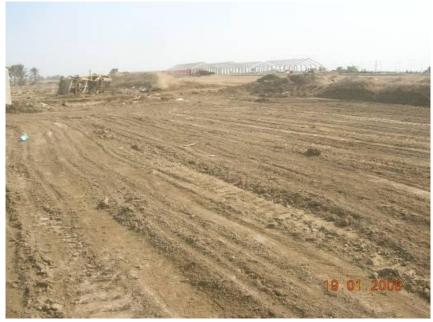
**Site Photo 1. Initial excavation of site (Courtesy of GRS)**

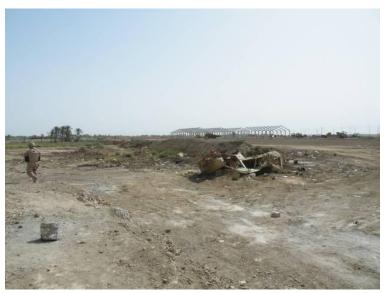
General topography of the area was flat with vacant or agricultural land extending for a significant distance from the site (Site Photo 2). Adjacent to the project was land currently used for agricultural research by the Ministry of Agriculture (Site Photo 3). A primary highway extended along the front of the project site; however, the facility was set back approximately 300 meters from the primary highway.

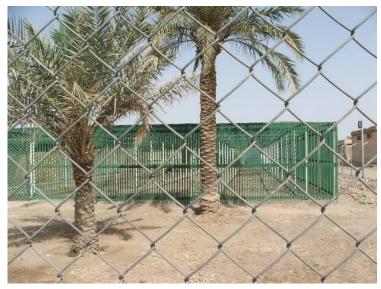
Site Photo 3. Agricultural use of land

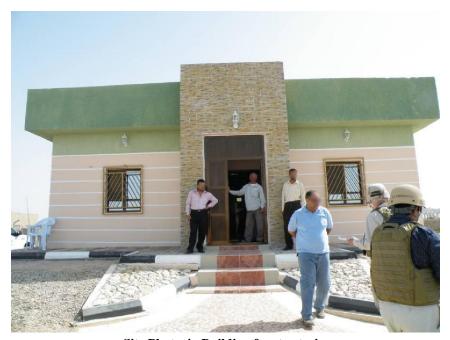
The building was square in shape with a prominent entry. The exterior of the building was finished with plaster and painted in a decorative, horizontal-striped pattern. The horizontal stripes were inset into the plaster finish creating a permanent architectural feature on the exterior of the building. The entryway to the building was finished with ceramic tile to create a contrasting pattern to the building finish (Site Photo 4). The exterior walls were in good condition with no evidence of cracking or settlement. Corners appeared true and plumb and the overall structure appeared sound.

Downspouts were constructed along the exterior walls to drain runoff from the roof. The downspouts were in good condition. The downspouts discharge directly onto the perimeter sidewalk adjacent to the building. With the discharge directly onto the sidewalk, the facility will require long-term maintenance.

Site Photo 4. Building front exterior

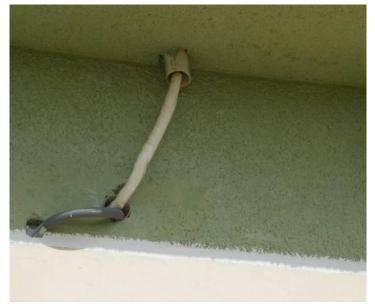
The building was constructed with a flat roof. The roof held several of the utilities for the building—including the water storage tanks and the compressor units for the split unit air conditioners. Coolant lines for the air conditioning units were run through the roof overhang and through wall penetrations to the condensers on the interior of the building (Site Photo 5).

Site Photo 5. Coolant line penetrating roof and wall

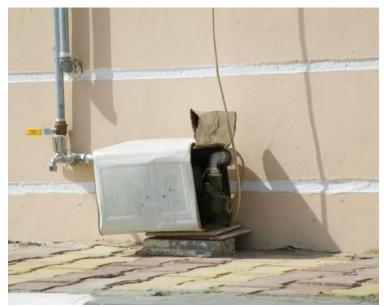
A transfer pump was located along the exterior wall of the building (Site Photo 6). Instead of connecting to the municipal system, as detailed on the design drawings, the contractor installed a transfer pump to convey water to the rooftop storage tanks. Based on this configuration, water can be supplied by tanker trucks. Due to the multiple connections and handling that must be performed to supply water to the facility, proper hygiene is critical to ensure that contamination is not introduced into the water supply at any point in the delivery cycle. This is especially important if the water is to be used to process honey.

Site Photo 6. Water transfer pump

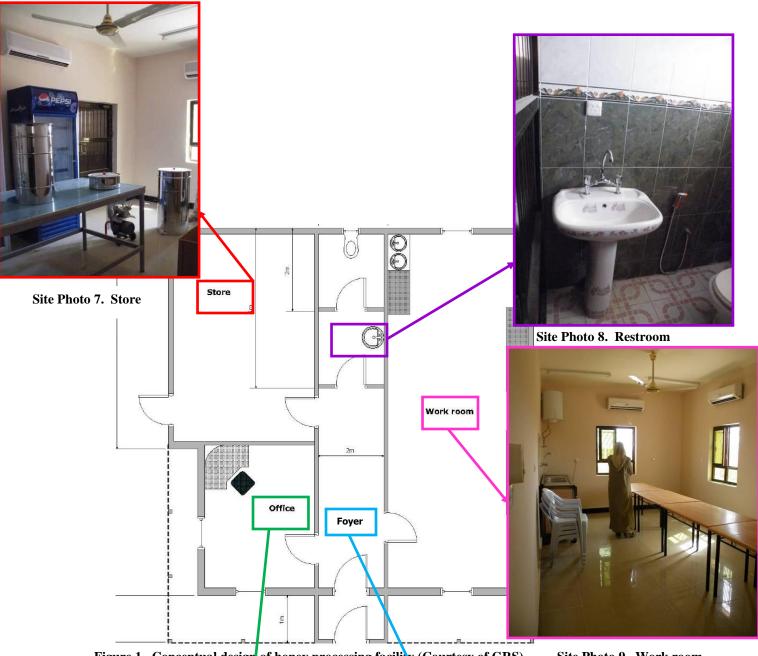
The building was constructed with three primary rooms and one restroom (Figure 1). The finish in all of the rooms was similar—plaster and painted finish for the walls, and ceramic tiles for the flooring. The finishes appeared well applied and in good condition.

Figure 1. Conceptual design of honey processing facility (Courtesy of GRS)

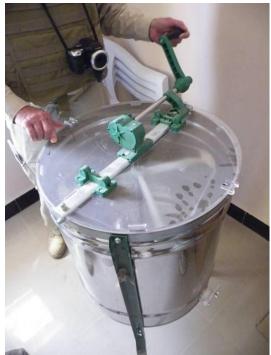
Site Photo 12. Extractor

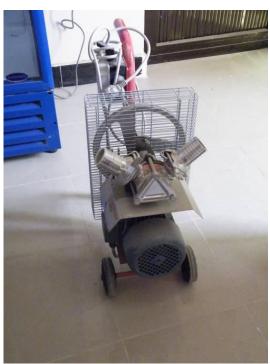
Site Photo 13. Transfer pump

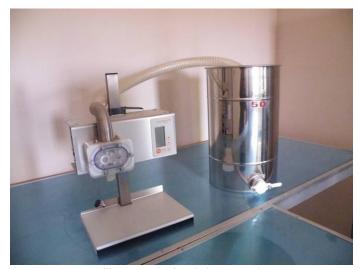
Site Photo 14. Filling machine

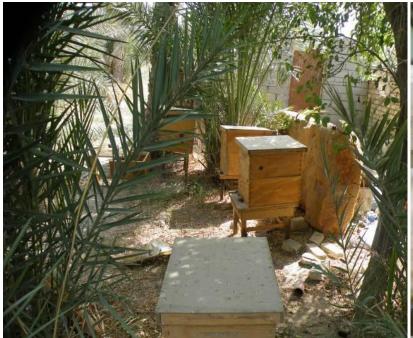
The GRS AAO representative and the security team accompanied SIGIR on a tour of a local apiary that received the queen and bees<sup>9</sup>, beehives<sup>10</sup>, and personal protective equipment<sup>11</sup> under this contract. SIGIR was able to identify the manufactured hives used to house the bees (Site Photo 15).

Site Photo 15. Bee hives

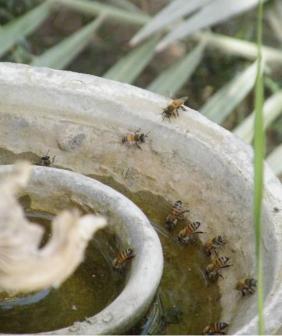
Due to the current drought conditions in Iraq, there is not enough vegetation to sustain a high concentration of bee colonies. In order to maintain honey production, the beekeepers are providing the bee colonies with sweetened water (Site Photo 16).

Site Photo 16. Sweetened water
